**Re: Beckner Road Improvements; Unpermitted Discharge/CGP; SIC 1542; NPDES
Compliance Evaluation Inspection; NPDES #NMU001945; September 27, 2017**

NPDES Compliance Inspection Report

**Beckner Road Improvements
Compliance Evaluation Inspection
Construction General Permit
NPDES Permit NMU001945
Date of Inspection: September 27, 2017**

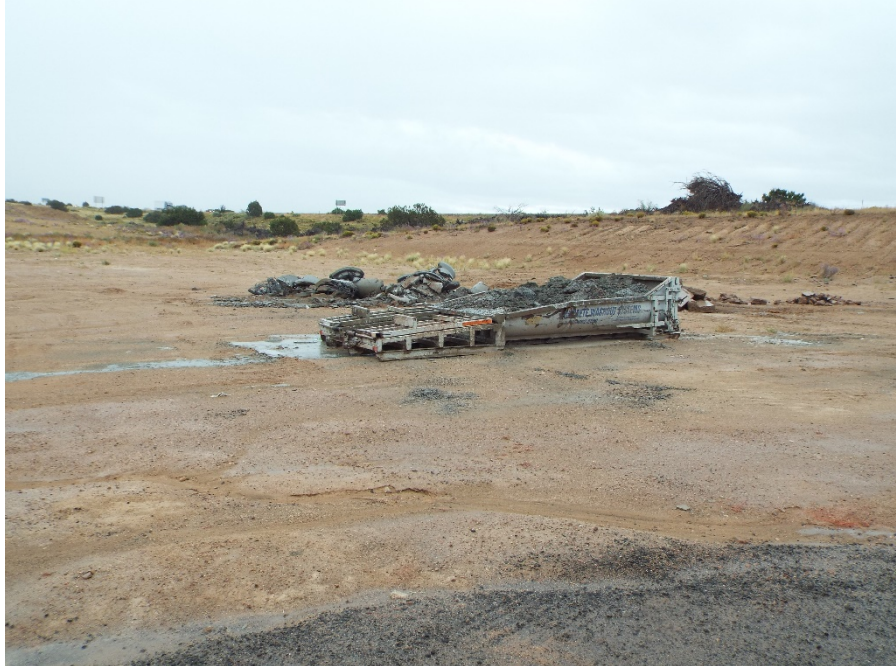
BMPs have not been adequately maintained or installed (Photo 3-8. Attachment 1)

NMED/SWQB Official Photograph Log Photo # 3		
Photographer: Daniel Valenta	Date: 9-27-17	Time: Approx 10:30 am
City/County: Santa Fe/Santa Fe		State: New Mexico
Location: Beckner Road Improvements Project		
Subject: Concrete washout at staging area needs to be emptied, concrete washout on ground

Location	Corrective Action Needed	Date and Time Noted	Date Completed	Initials
Construction yard	Need Empty Portable Concrete washout bin. Also, and clean spoils around container.	9-20-2017 11:44 A.M.		
Rail runner South to Jaynes Presbyterian South entrance Hospital	Sweep West and East sides of Blvd For Debris.	9-20-2017 11:44 A.M.		
Staging Area	Need to refresh the tracking control at the staging area.	9-20-2017 11:44 A.M.		
Westside from Walking rain to Rail runner	Need to sweep.	9-20-2017 11:44 A.M.		
Concrete Washout area	Remove pile of Asphalt.	9-20-2017 11:44 A.M.		
N/E New paved area	Remove or stabilize Dirt stock piles.	9-20-2017 11:44 A.M.		
Southeast side of Los Soleras.	Remove or stabilize Dirt stock piles.	9-20-2017 11:44 A.M.		
North of Rail runner	Clean inlet protection.	9-20-2017 11:44 A.M.		
North West of Los Soleras.	Clean inlet protection.	9-20-2017 11:44 A.M.		
South of Los Soleras	Clean inlet protection.	9-20-2017 11:44 A.M.

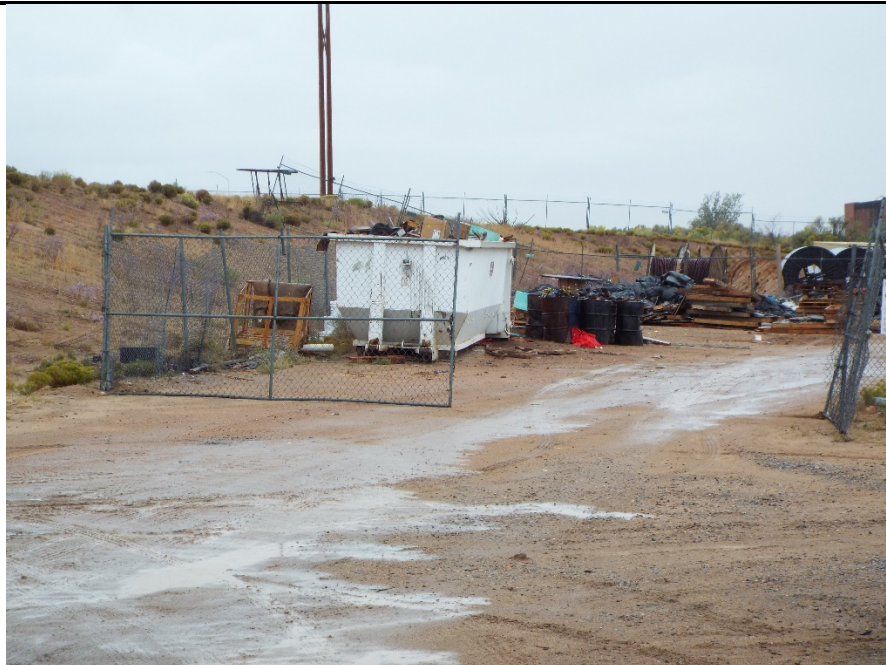
NMED/SWQB Official Photograph Log Photo # 4		
Photographer: Daniel Valenta	Date: 9-27-17	Time: Approx 10:30 am
City/County: Santa Fe/Santa Fe		State: New Mexico
Location: Beckner Road Improvements Project		
Subject: uncovered dumpster at staging area

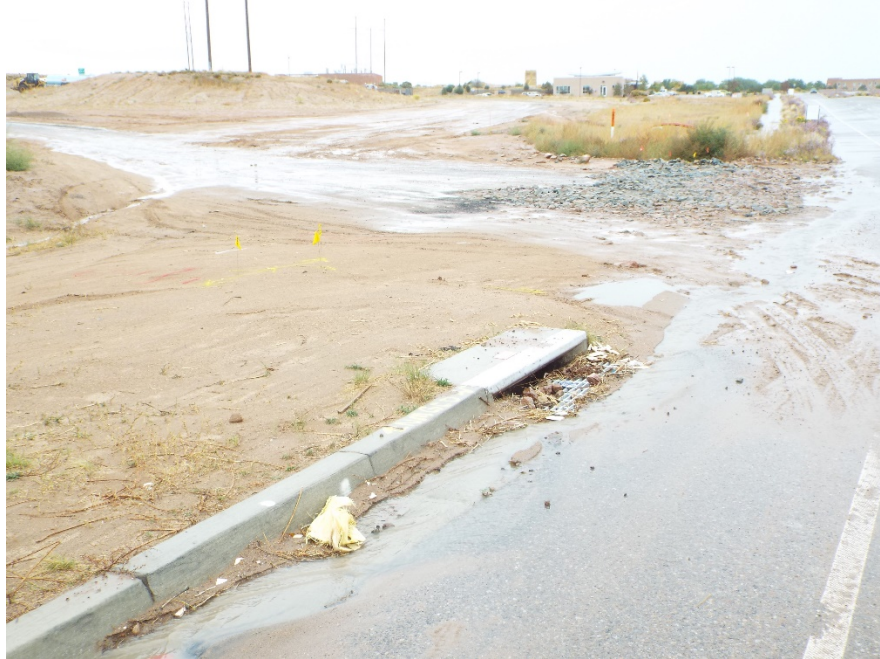
NMED/SWQB Official Photograph Log Photo # 5		
Photographer: Daniel Valenta	Date: 9-27-17	Time: Approx 10:30 am
City/County: Santa Fe/Santa Fe		State: New Mexico
Location: Beckner Road Improvements Project		
Subject: storm drain with sediment and debris and no protection at staging area entrance

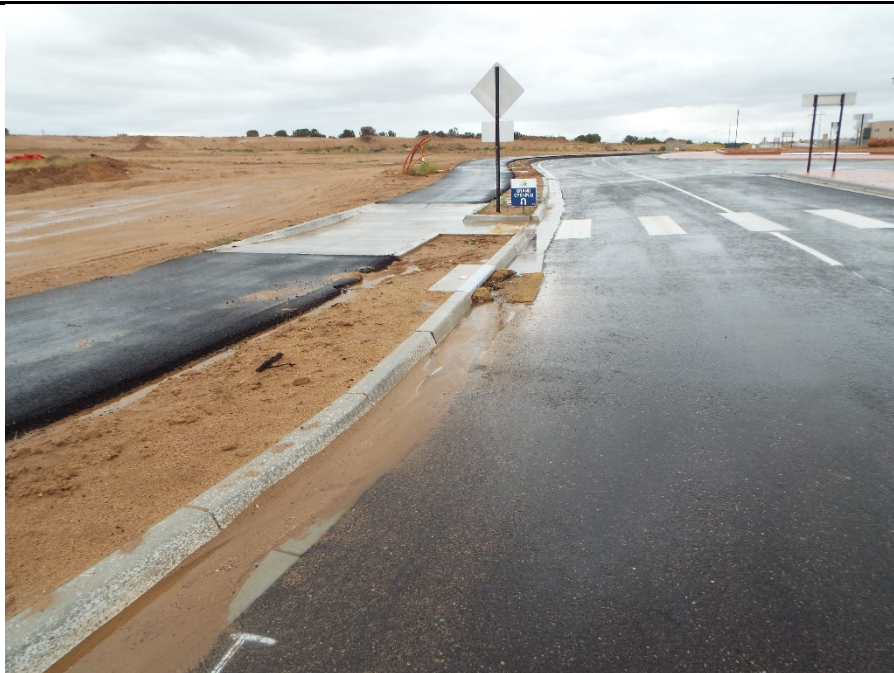
NMED/SWQB Official Photograph Log Photo # 6		
Photographer: Daniel Valenta	Date: 9-27-17	Time: Approx 10:30 am
City/County: Santa Fe/Santa Fe		State: New Mexico
Location: Beckner Road Improvements Project		
Subject: functional inlet protection, need to remove sediment

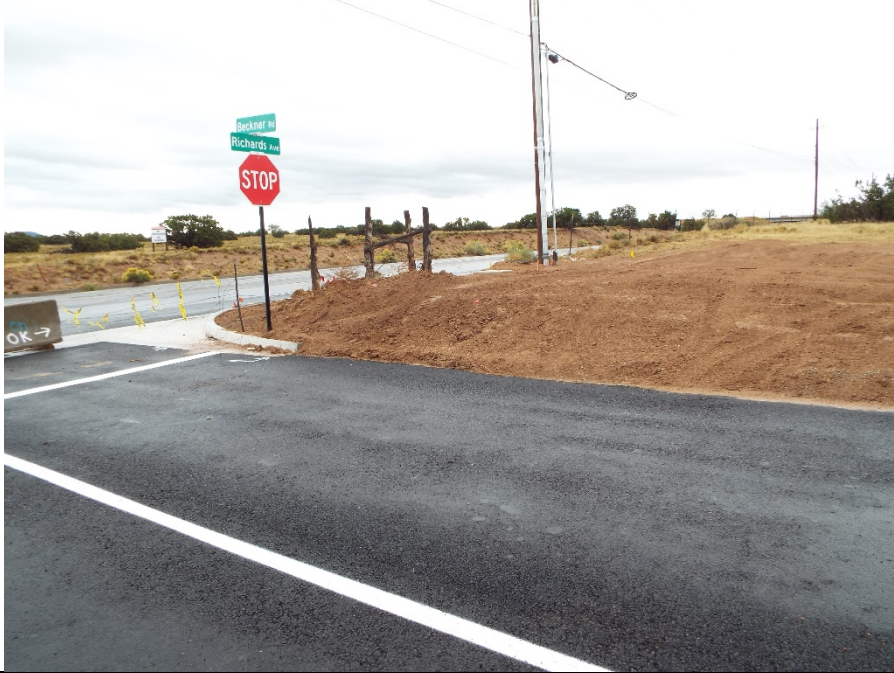
NMED/SWQB Official Photograph Log Photo # 7		
Photographer: Daniel Valenta	Date: 9-27-17	Time: Approx 10:30 am
City/County: Santa Fe/Santa Fe		State: New Mexico
Location: Beckner Road Improvements Project		
Subject: no BMPs on downhill side of disturbed soils

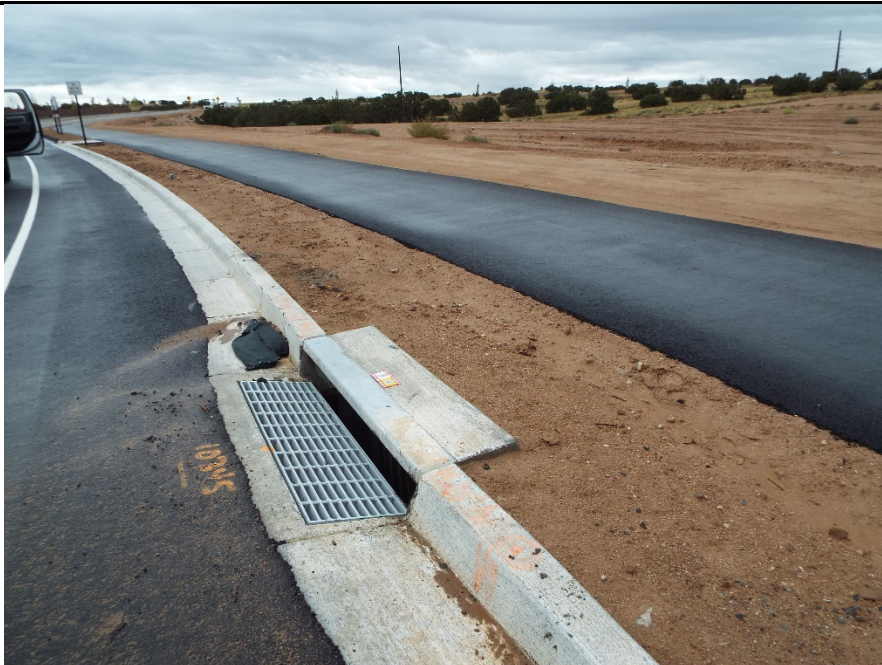
NMED/SWQB Official Photograph Log Photo # 8		
Photographer: Daniel Valenta	Date: 9-27-17	Time: Approx 10:30 am
City/County: Santa Fe/Santa Fe		State: New Mexico
Location: Beckner Road Improvements Project		
Subject: inlet with inadequate protection
